It is a potential problem to use an older drive in a newer Click-n-Go hull.

Revised 6/24/2009

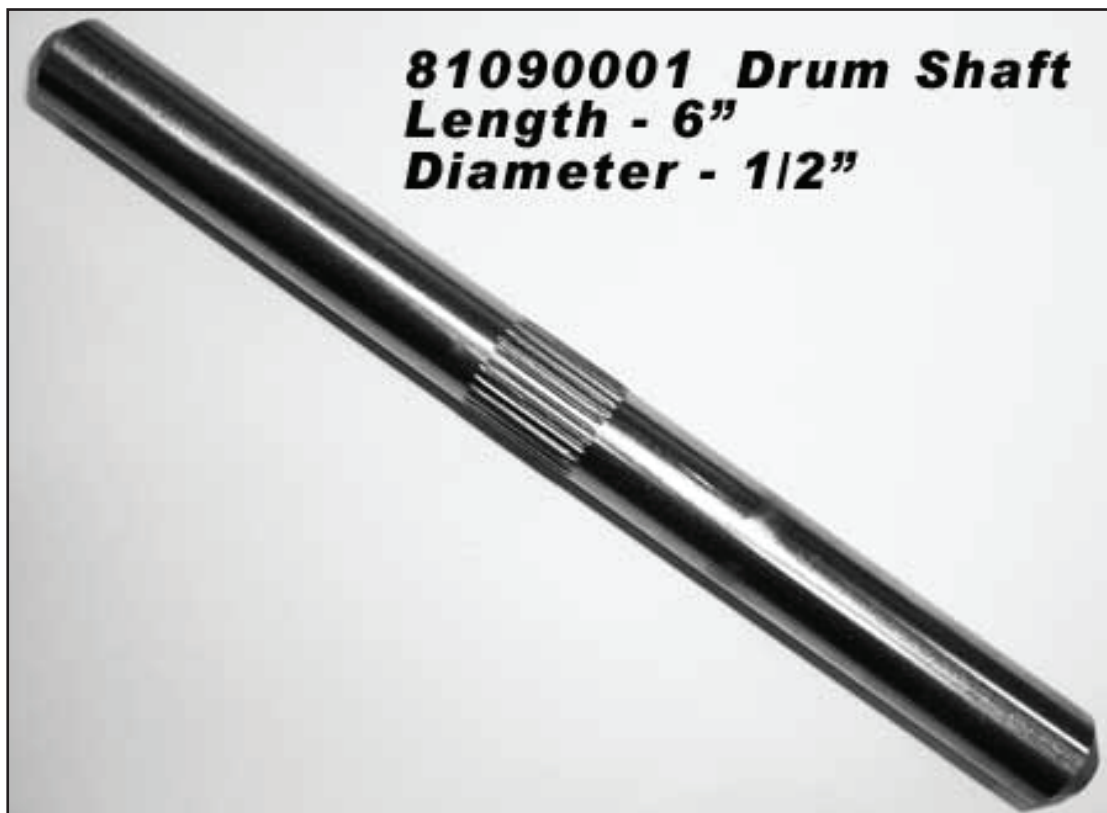
Problem: The drum shaft in an older drive can rotate within the drive. The levers pinch the shaft and as the drive rocks... This can "ratchet" open the Click-n-Go lever and release the drive.

The newer drum shafts (Spring 2008 / 2009 Model year) for the Click-n-Go lever system have splines to prevent this rotation. The shaft ends are beveled rather than rounded.

The drum shaft is easy to replace.
Simply hammer out the old shaft with the new one.
Center the shaft in the Drive and thats it.
