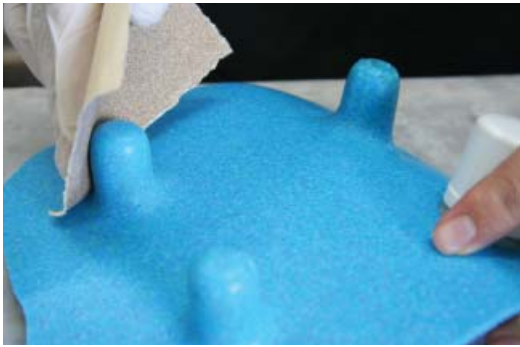
1) Reaching inside the 8" Twist and Stow hatch forward of the seating area, locate the cracked seat plug scupper. Using the provided sandpaper, sand the surface of the column on the inside of the boat.

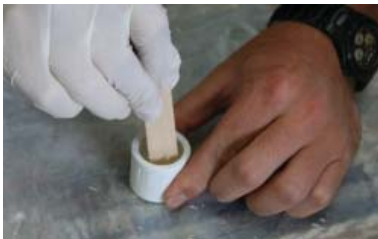
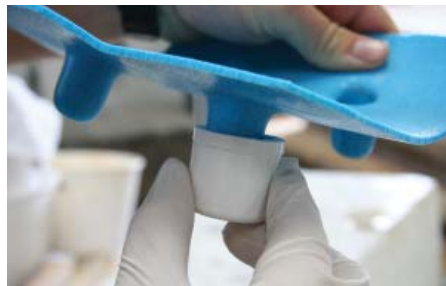
2) Using the provided PVC cap and two-part epoxy, follow the instructions on the epoxy and fill the cap half way. Using the provided mixing stick, mix the two-part epoxy together inside the cap until fully mixed.

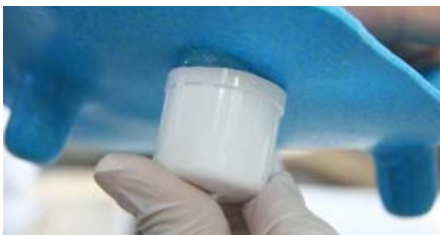
3) While wearing a rubber glove, insert cap onto cracked scupper until it bottoms out, holding it in place for at least 3 minutes.
