2015 Pro Angler skeg line reroute

84610122 PA SKEG LINE KIT:

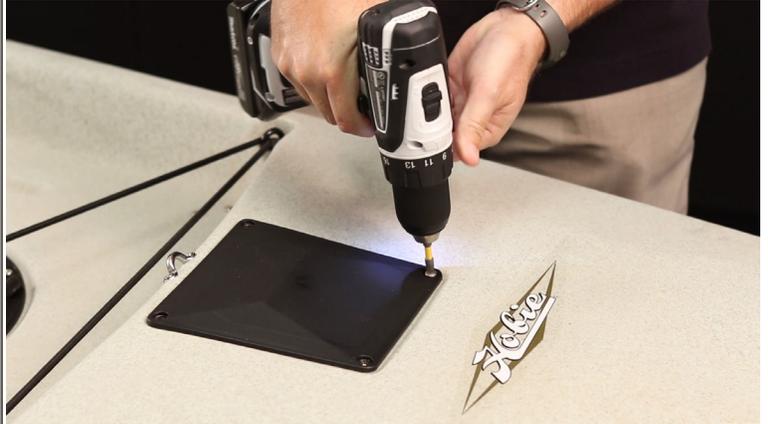
- ① Remove the 4 screws from the steering cover plate.

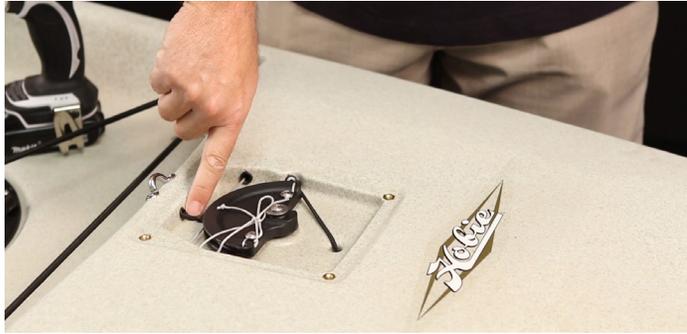
- ② If the skieg line exits the hull at the front of the steering box, continue with this upgrade. If the skieg line comes from the side, you do not need to do this.

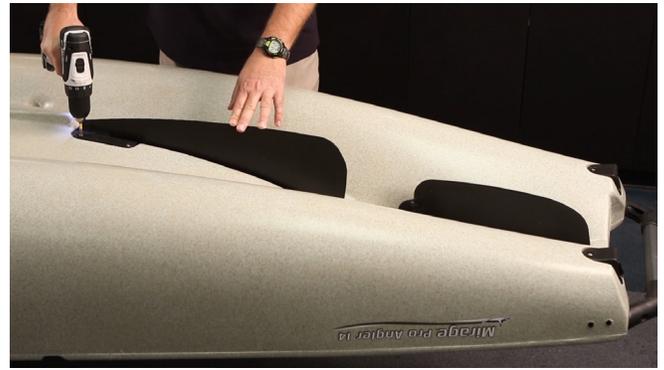
- ③ Turn your boat on its side or upside down and remove the 4 screws from the skieg housing.

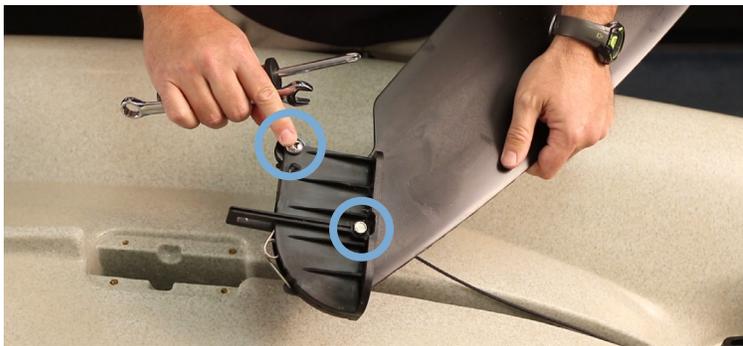
- ④ Release the skieg line from the cleat. Without removing the skieg from the housing, remove the screw and bolt from the pulley and pivot. Untie and remove the line.

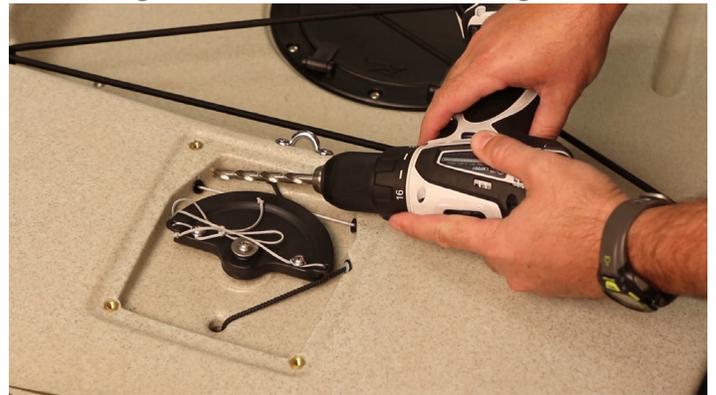
- ⑤ Using the 5/16" bit, drill a hole halfway between the steering line and front of the steering box.

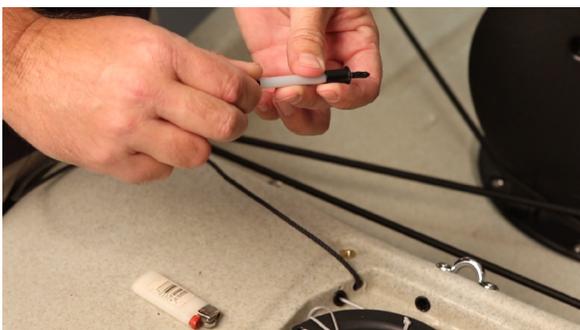
- ⑥ Reach inside the rear hatch and pull the skieg line out. Reroute the skieg line through the new hole ensuring that the line goes above the steering lines that criss cross at the back of the tankwell.

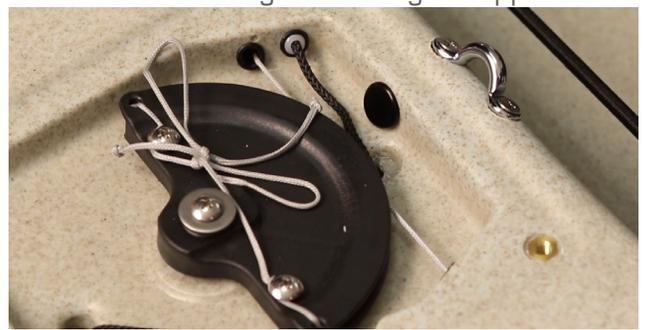
- ⑦ Feed the line through tube and grommet from the kit. You may need to burn the end of the line to help feed it through. Remove the old grommet and install the panel rivet. Pass skieg line through scupper hole.

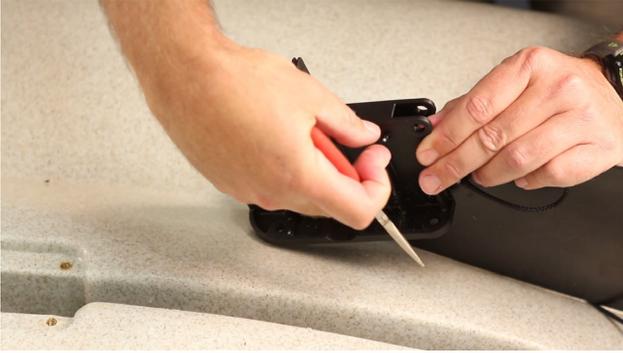
- ⑧ Pass the line through the hole in the skeg so it goes toward the hole on the side of the housing. Pass the line through the hole in the side of the housing.

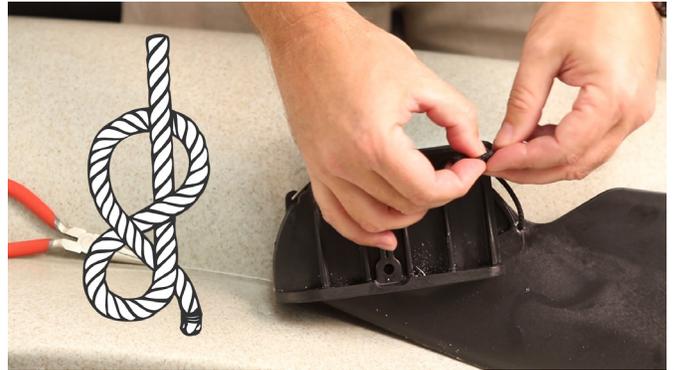
- ⑨ Tie a figure 8 knot to prevent the line from backing out.

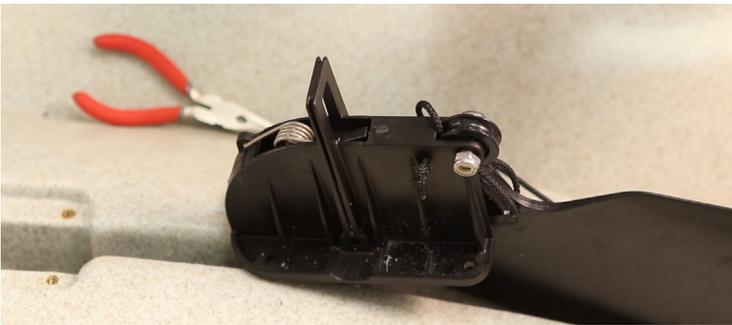
- ⑩ Reinstall the pulley and screw ensuring that the line is between the pulley and the housing. Do not overtighten, the pulley should spin freely.

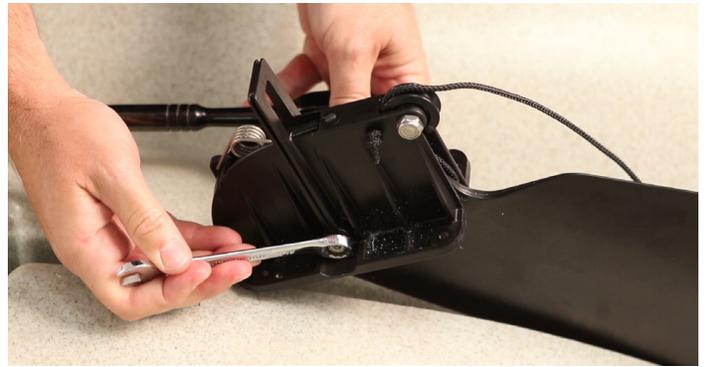
- ⑪ Install the pivot bolt. Do not overtighten, the skeg should move freely.

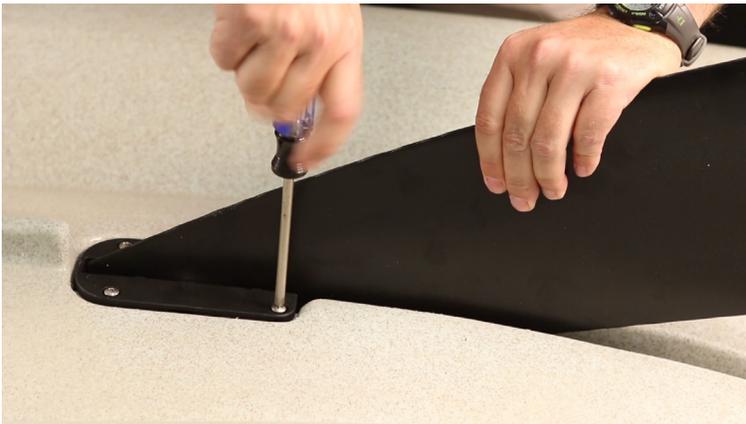
- ⑫ Reinstall the skeg housing using the 4 screws.

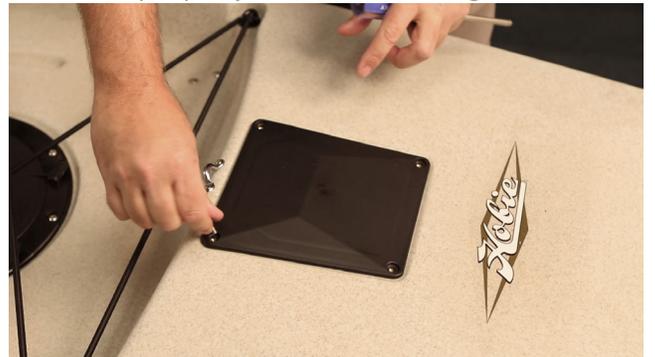
- ⑬ With the boat upright and the rear of the boat raised off the ground, test the function of the skeg. If it functions properly, reinstall steering cover.
